ESD Repair of Army Main Battle Tank Components

January 26, 2006

Army Research Laboratory, APG, MD

Anniston Army Depot

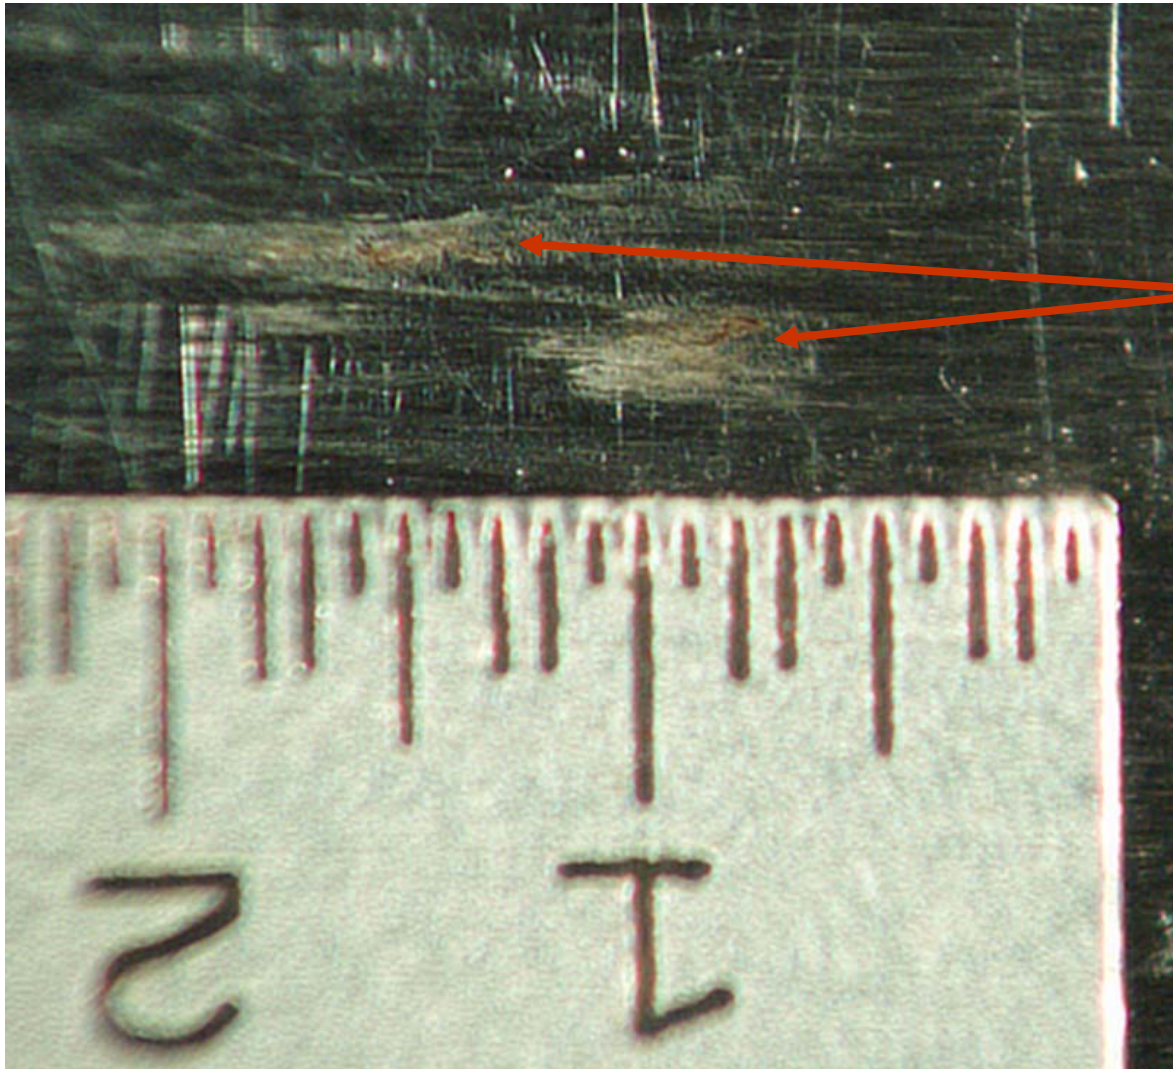
Corrosion Pits on M1 Sun Gear Shaft Chrome Plating

- Small corrosion pits and wear marks noted on chrome plated surfaces on the exterior and interior of the Sun Gear Shaft. Some damage extends into base metal
- Shaft is AISI 9310 steel with chrome plating in some regions.
- Shaft is part of the RGB (Reduction Gear Box), which transmits power from the M1's turbine engine to the transmission.
- The Sun Gear Shaft has an input RPM of 32,000, and drives a planetary gear with an output of 3,000 RPM.
- The seals which ride on the chrome plated surfaces are carbon based spring loaded seals, providing very low levels of wear to this part.

Corrosion Pits

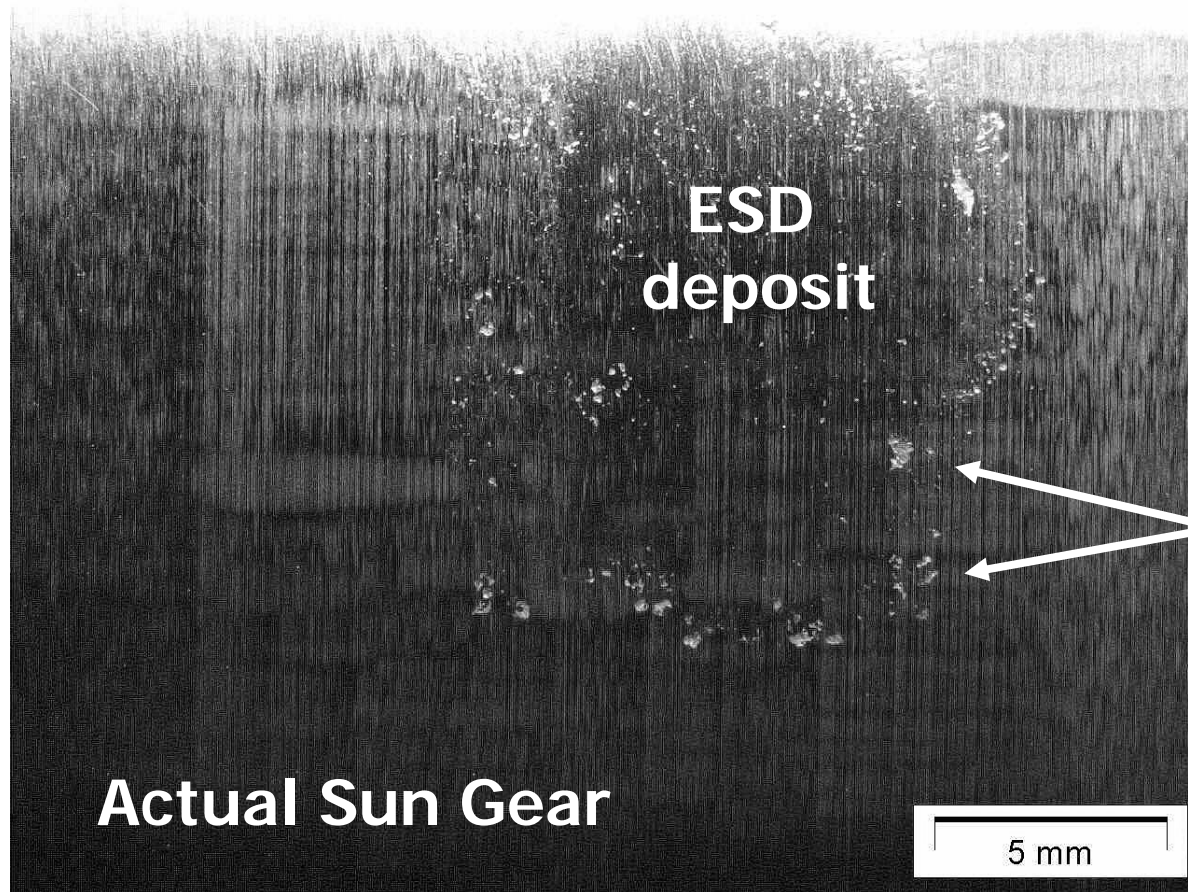
Defects Noted at Interface of Chrome and ESD

“Halo” effect
around periphery
of ESD deposit on
chrome-plated sun
gear.

Pitting at periphery of
deposit

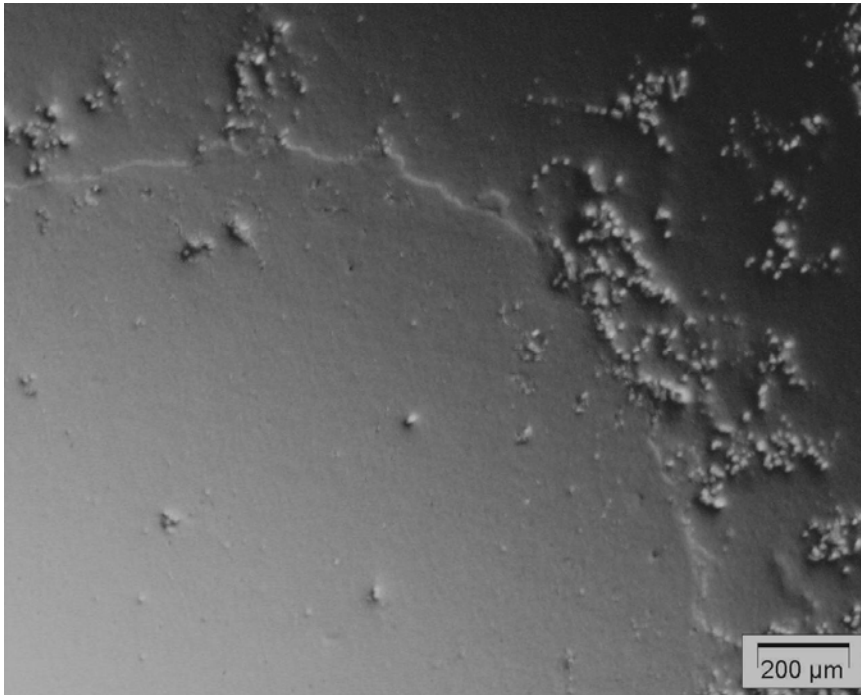
Inconsistent Results with ESD and Chrome Plating

- Repair of defects within chrome plating led to inconsistent ESD results. A defect characterized as the “Halo Effect” was noted in many cases. This defect occurs at the interface of the deposit and the chrome plated substrate. **This problem convinced ARL and ANAD to only repair pits and wear marks through the chrome plating into the base metal.**

“Halo” effect
around periphery
of ESD deposit on
chrome-plated sun
gear.

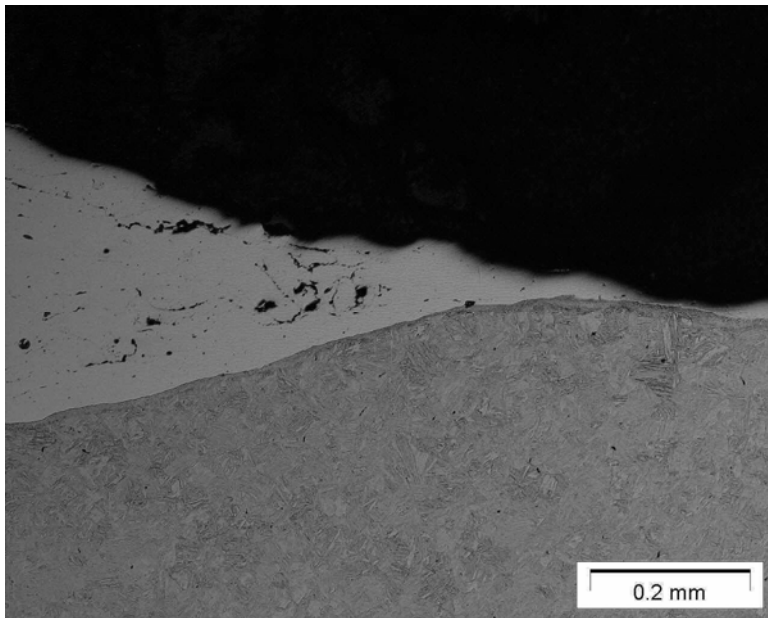
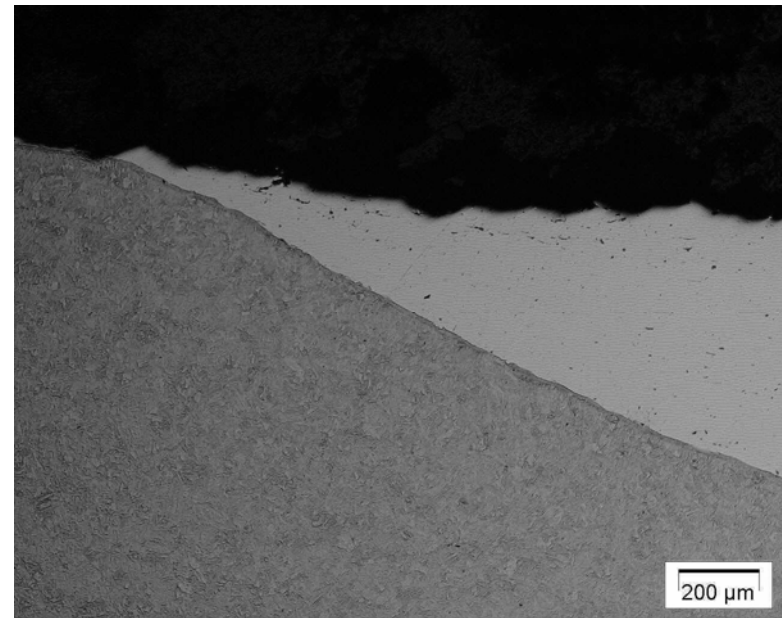
Defects Noted at Interface of Chrome and ESD Repair

- ESD of defects in chrome-plated steel yielded mixed results – porosity noted (left), defect-free repair (right).

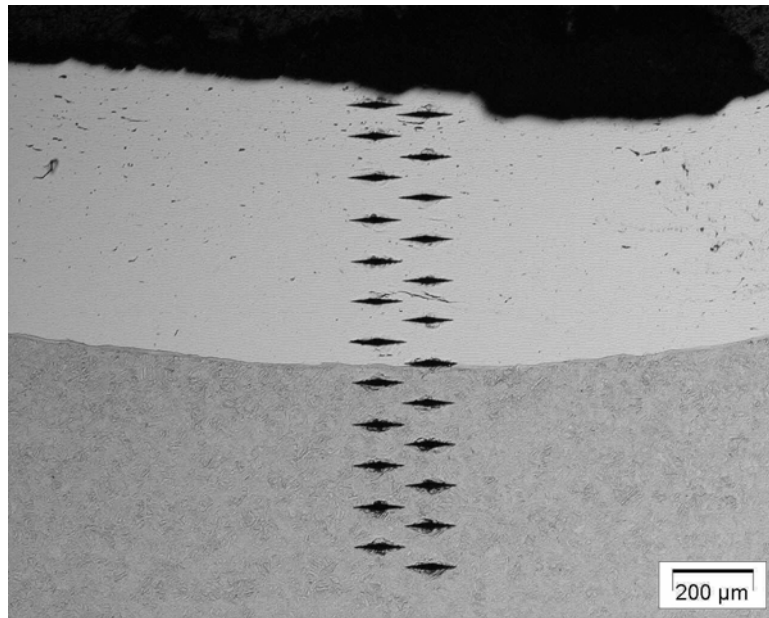
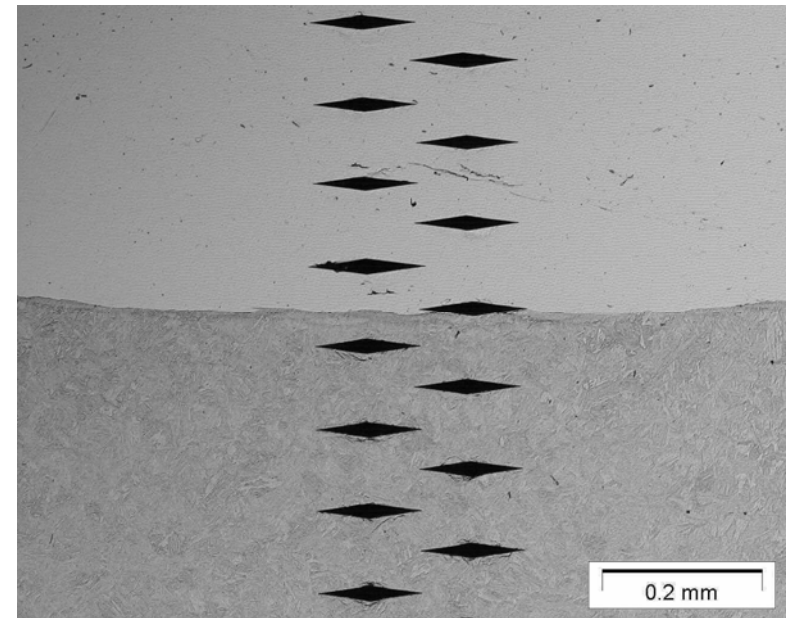
Microhardness Through an ESD Deposit

- Knoop microhardness measurements taken through ESD deposit into base material (AISI 9310). Photo on left is 50x magnification, photo on right is 100x magnification. No appreciable hardness difference between deposit and base material.

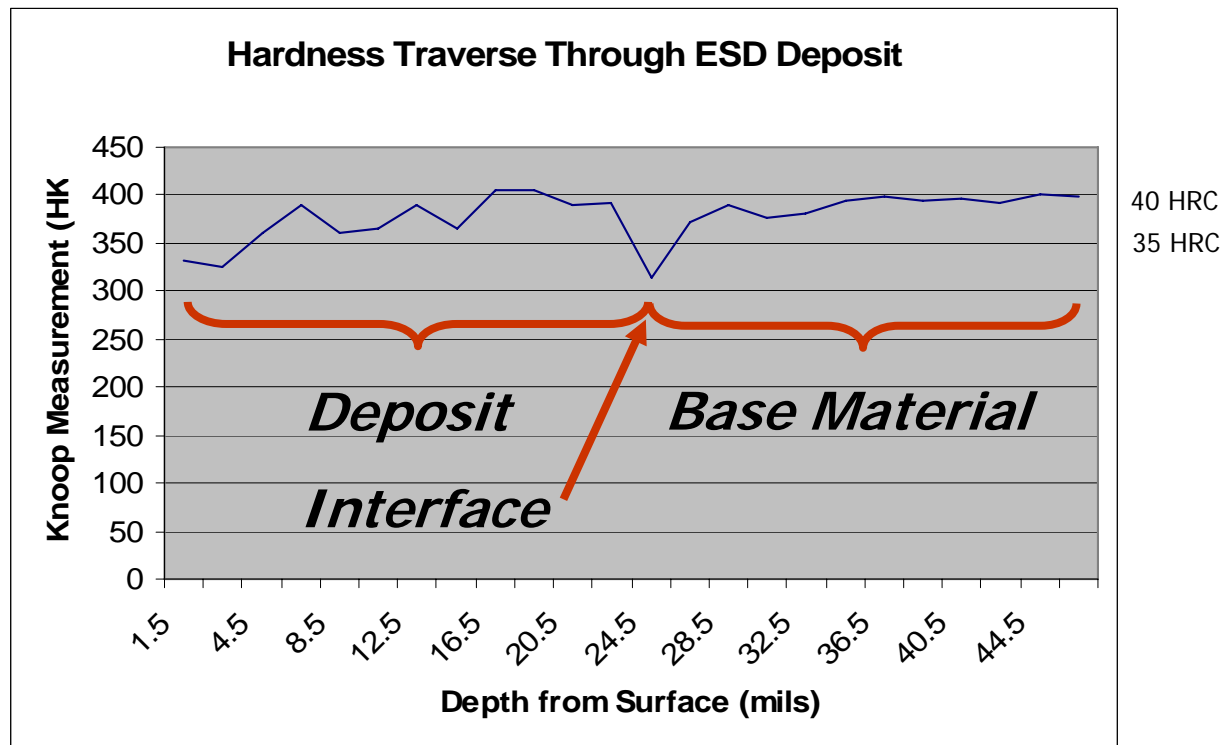
Microhardness Through an ESD Deposit

- Knoop microhardness measurements (500gmf load, 50x objective) were taken through ESD deposits into base material (AISI 9310). Typical hardness results are as shown:

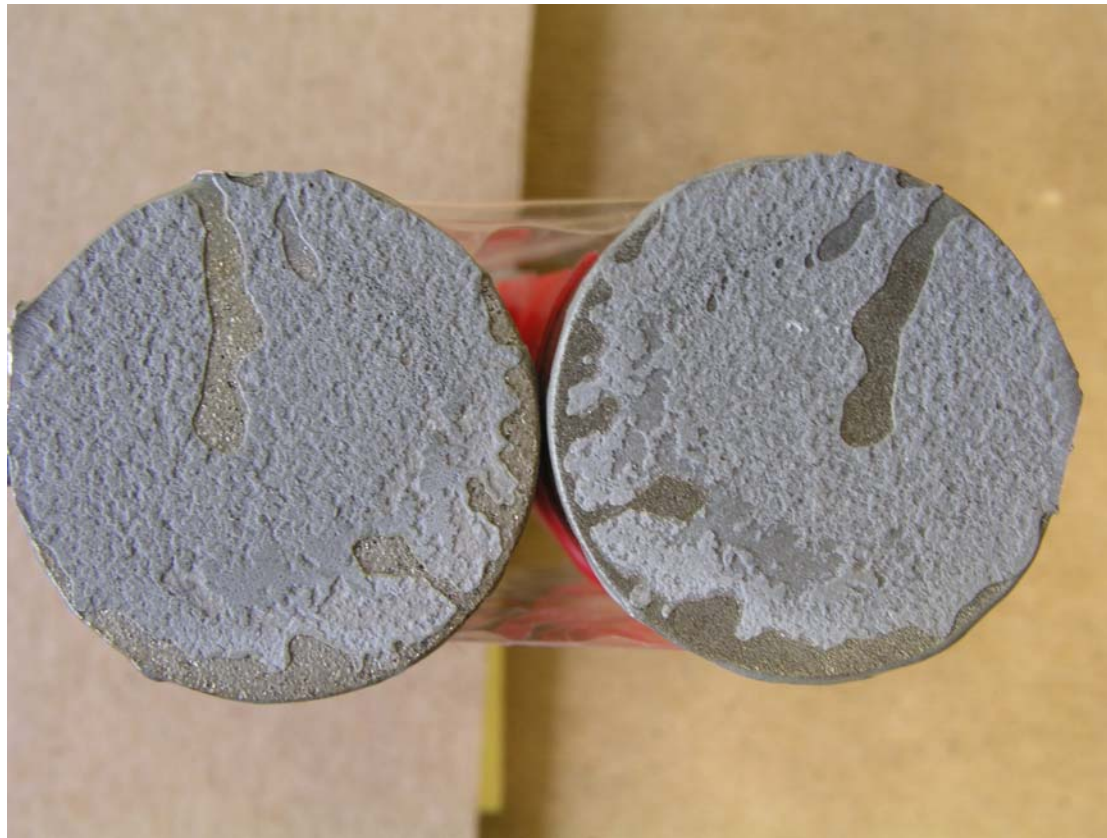
Tensile Test Bond Bars

Bond Bar	Tensile Strength (psi)
1	10,453
2	9559
3	7891
4	10,136
5	10,960

Note: All were adhesive bond failures
